STATE OF TENNESSEE
DEPARTMENT of SAFETY and HOMELAND SECURITY
TENNESSEE HIGHWAY PATROL
Critical Incident Response Team

Tennessee Highway Patrol Critical Incident Response Team

Investigative Summary

Location: Blythe Ferry Lane (Blythe Ferry Boat Ramp)

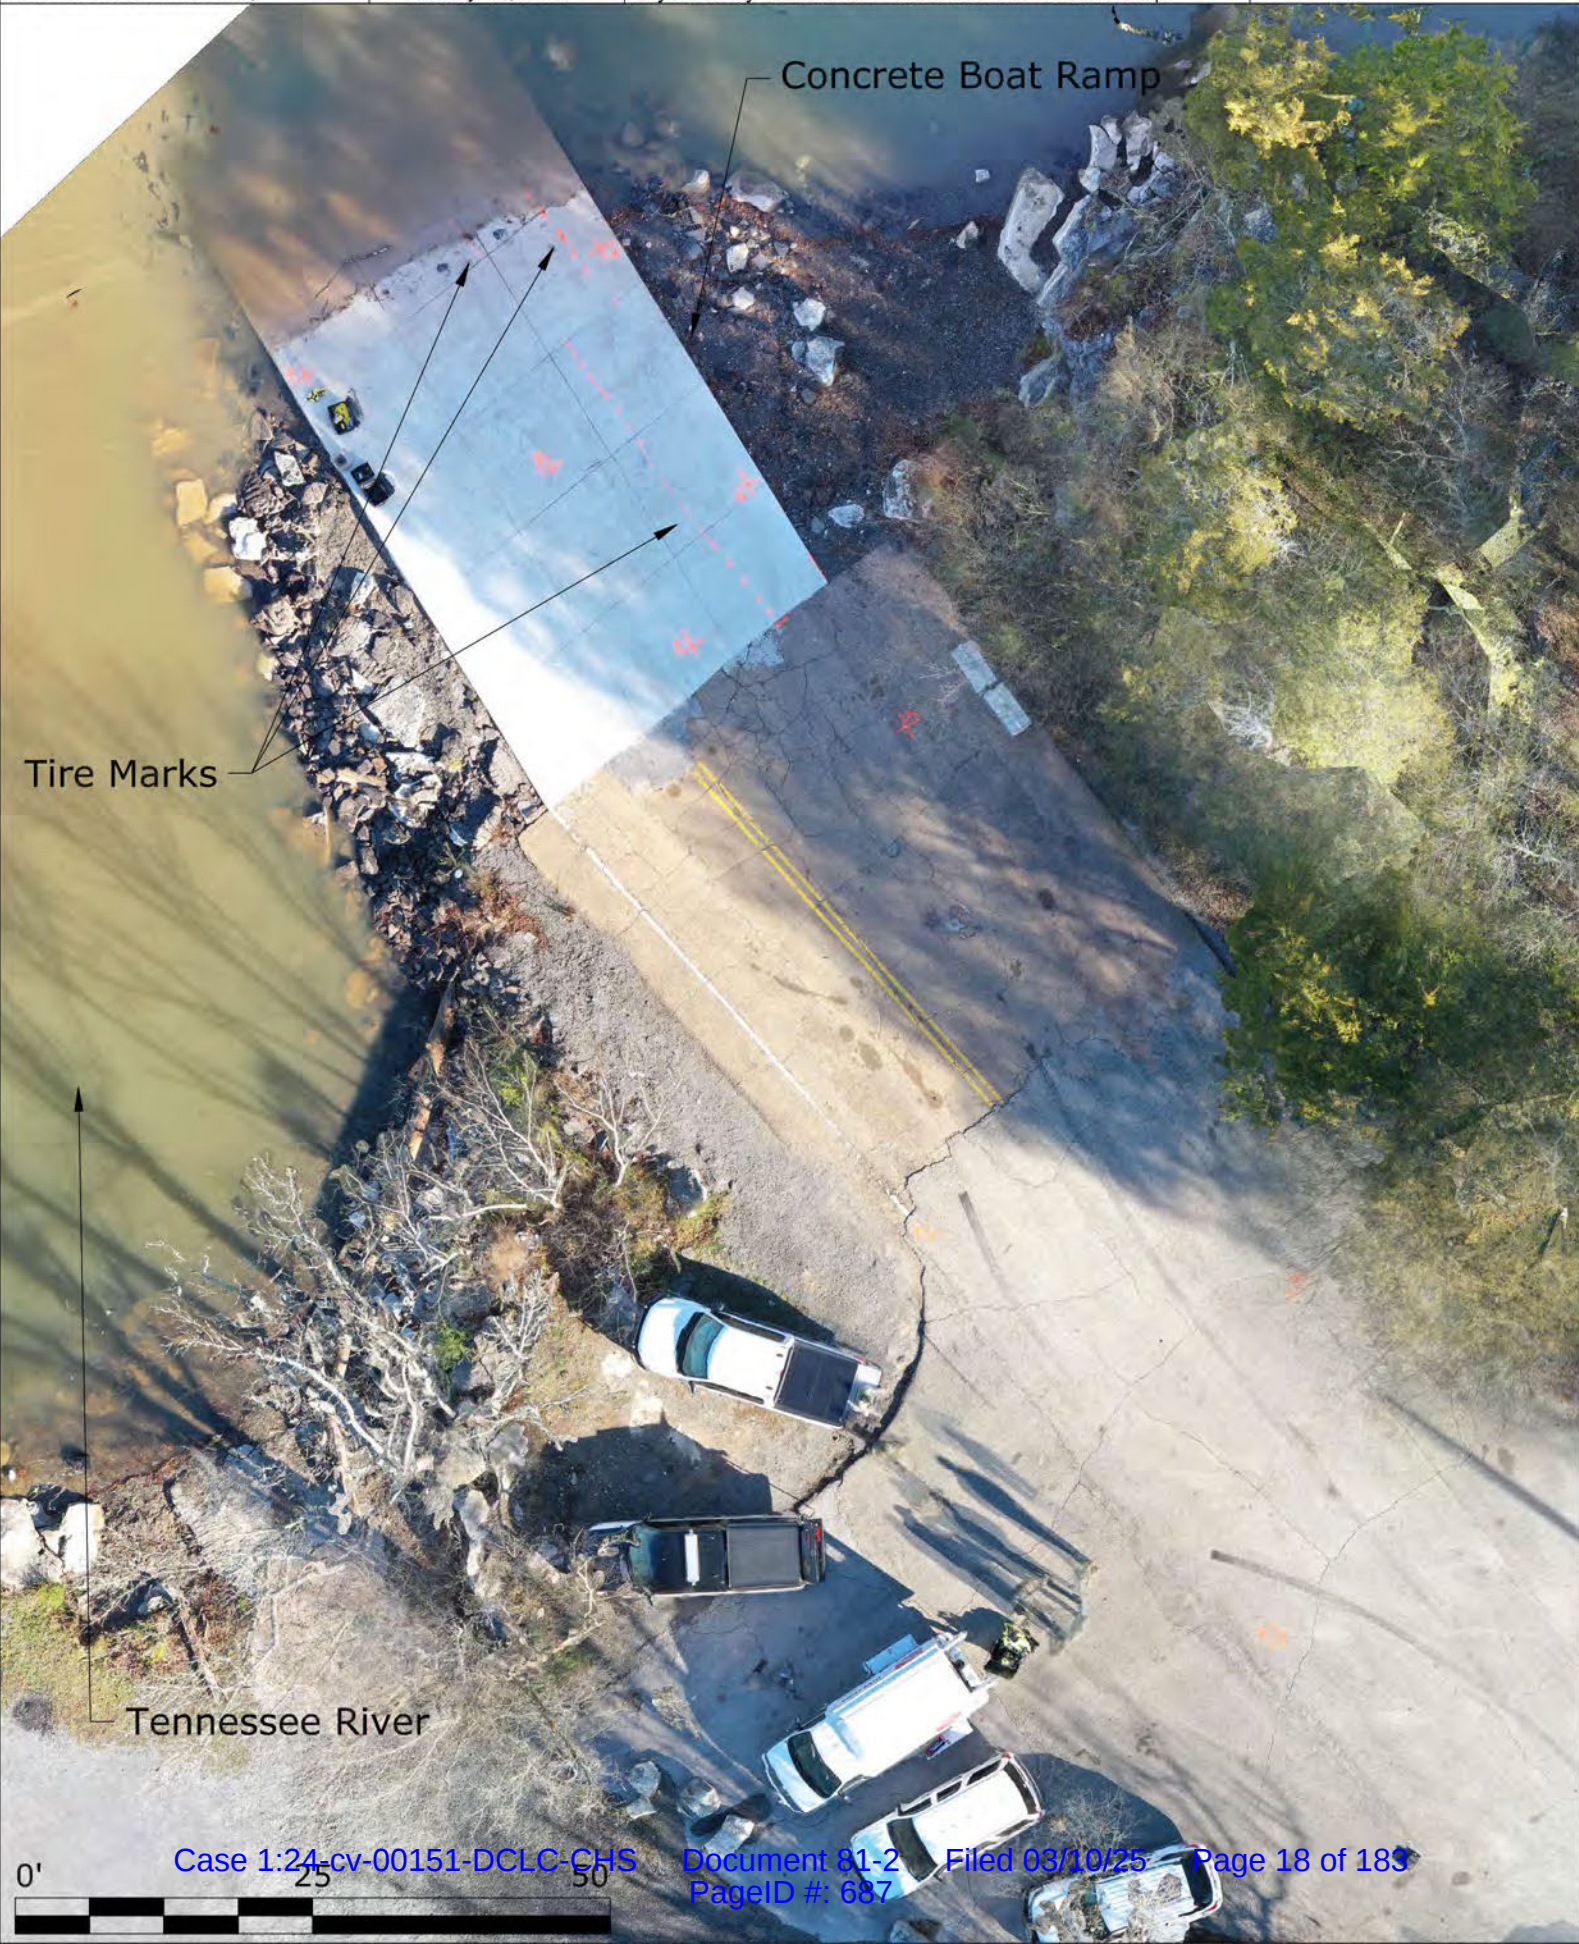
Concrete Boat Ramp

Tire Marks

Tennessee River

9. Brake marks were located on the boat ramp starting from the top and leading into the water. They were at an angle to the ramp itself and not parallel. No other roadway evidence was observed at the crash scene. (Crash scene.)

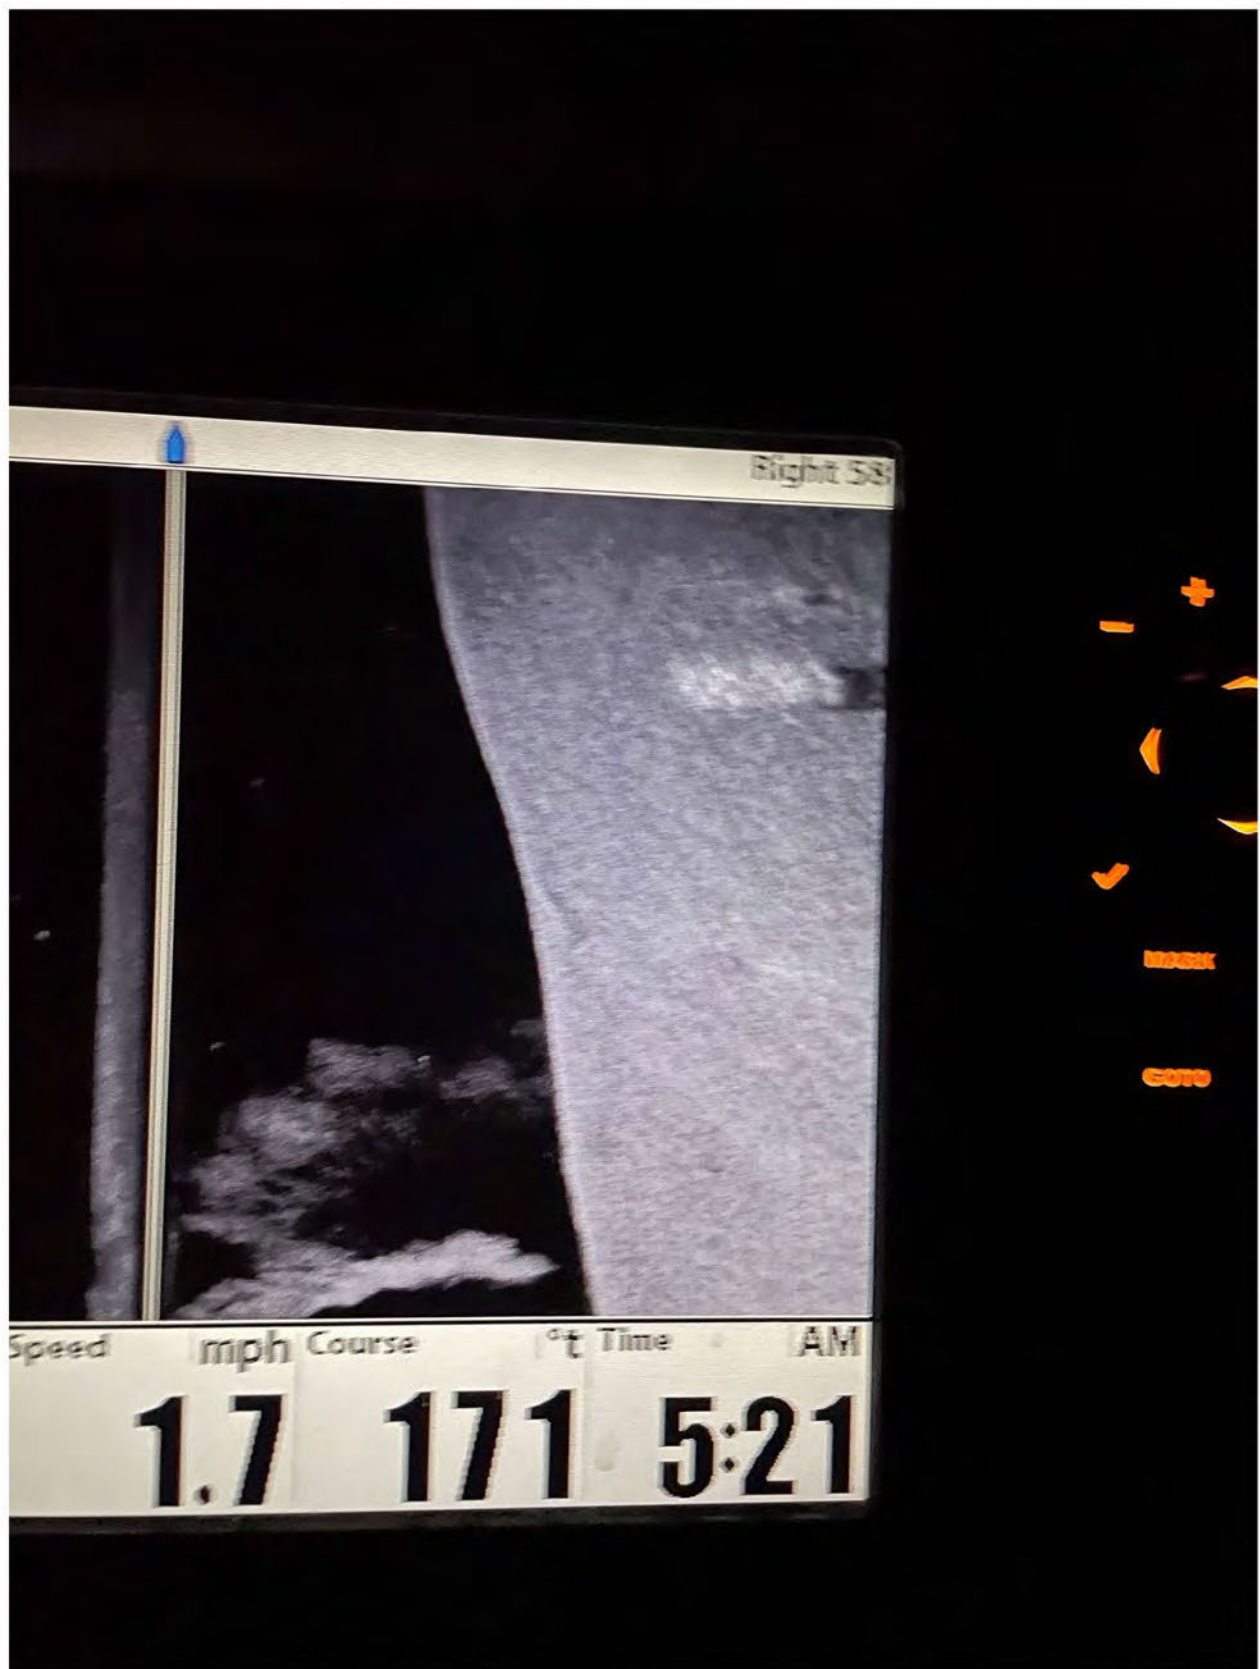
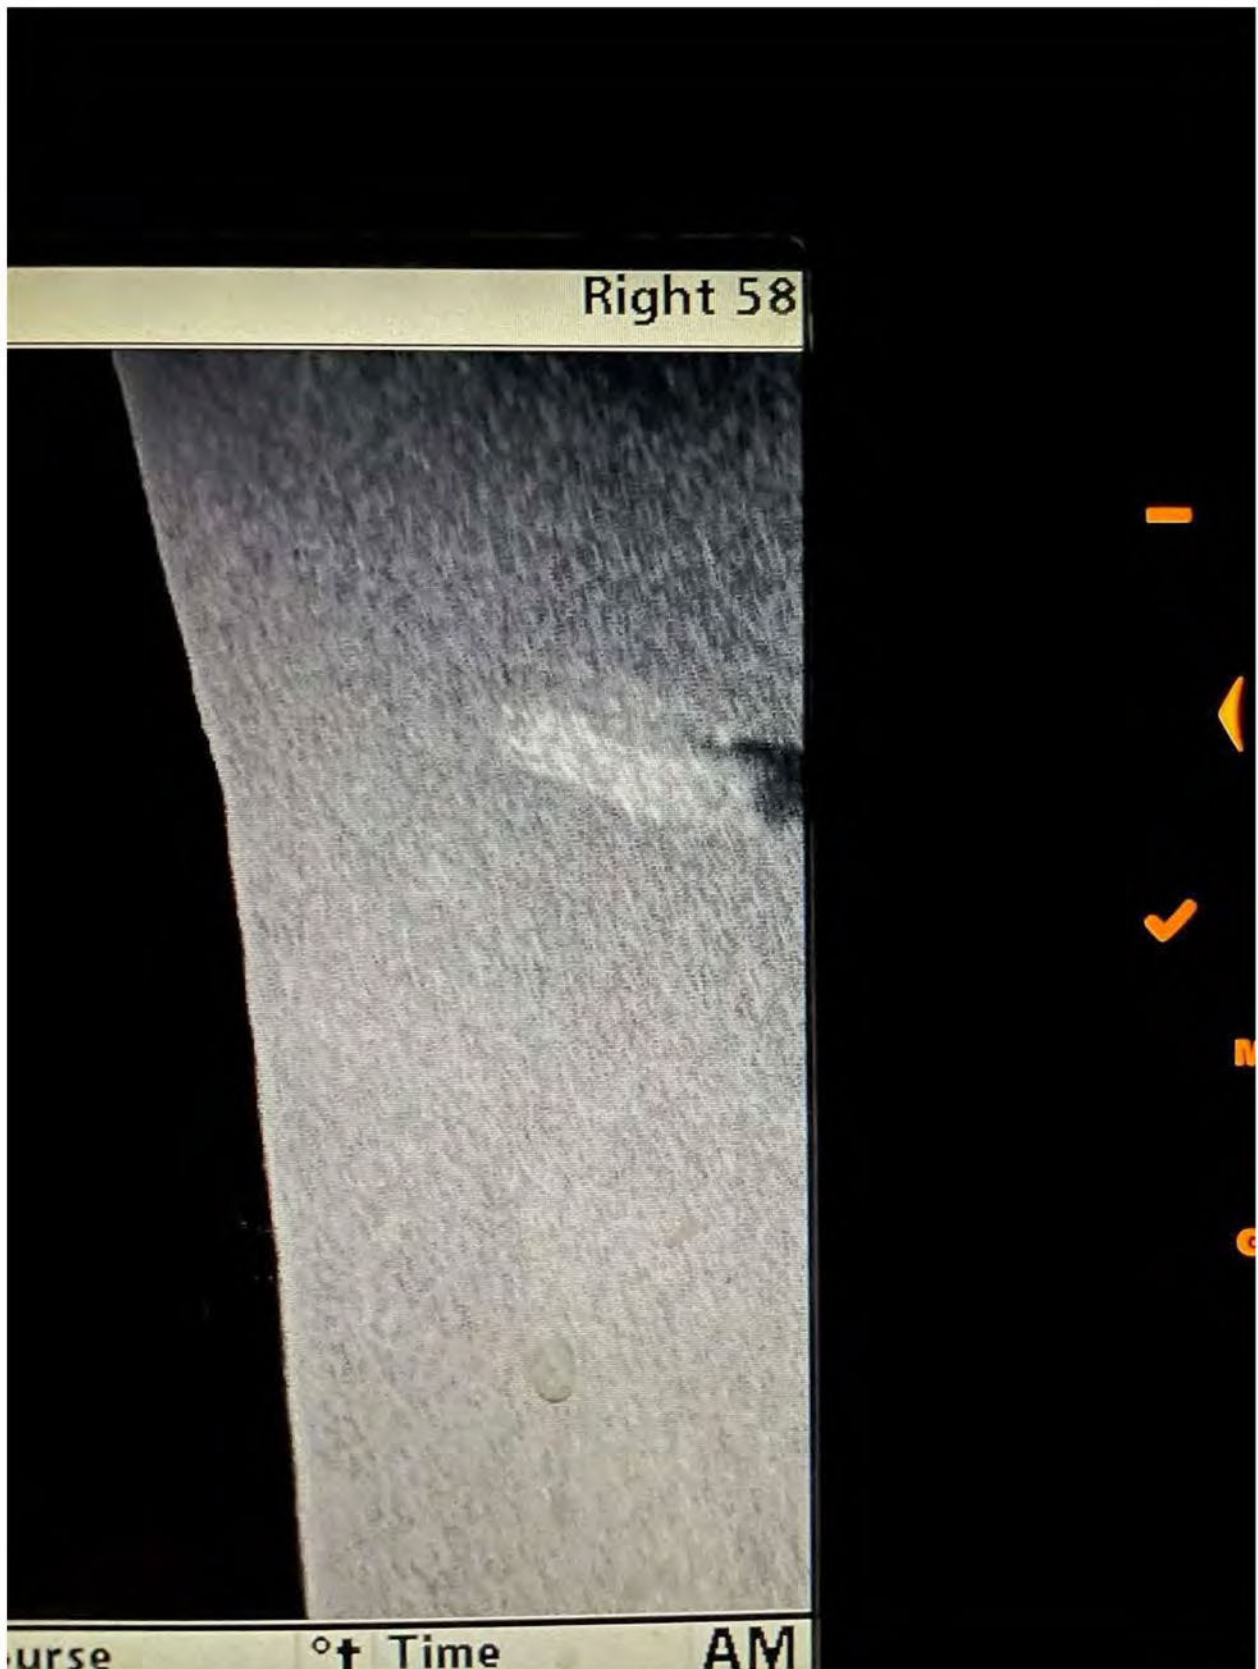
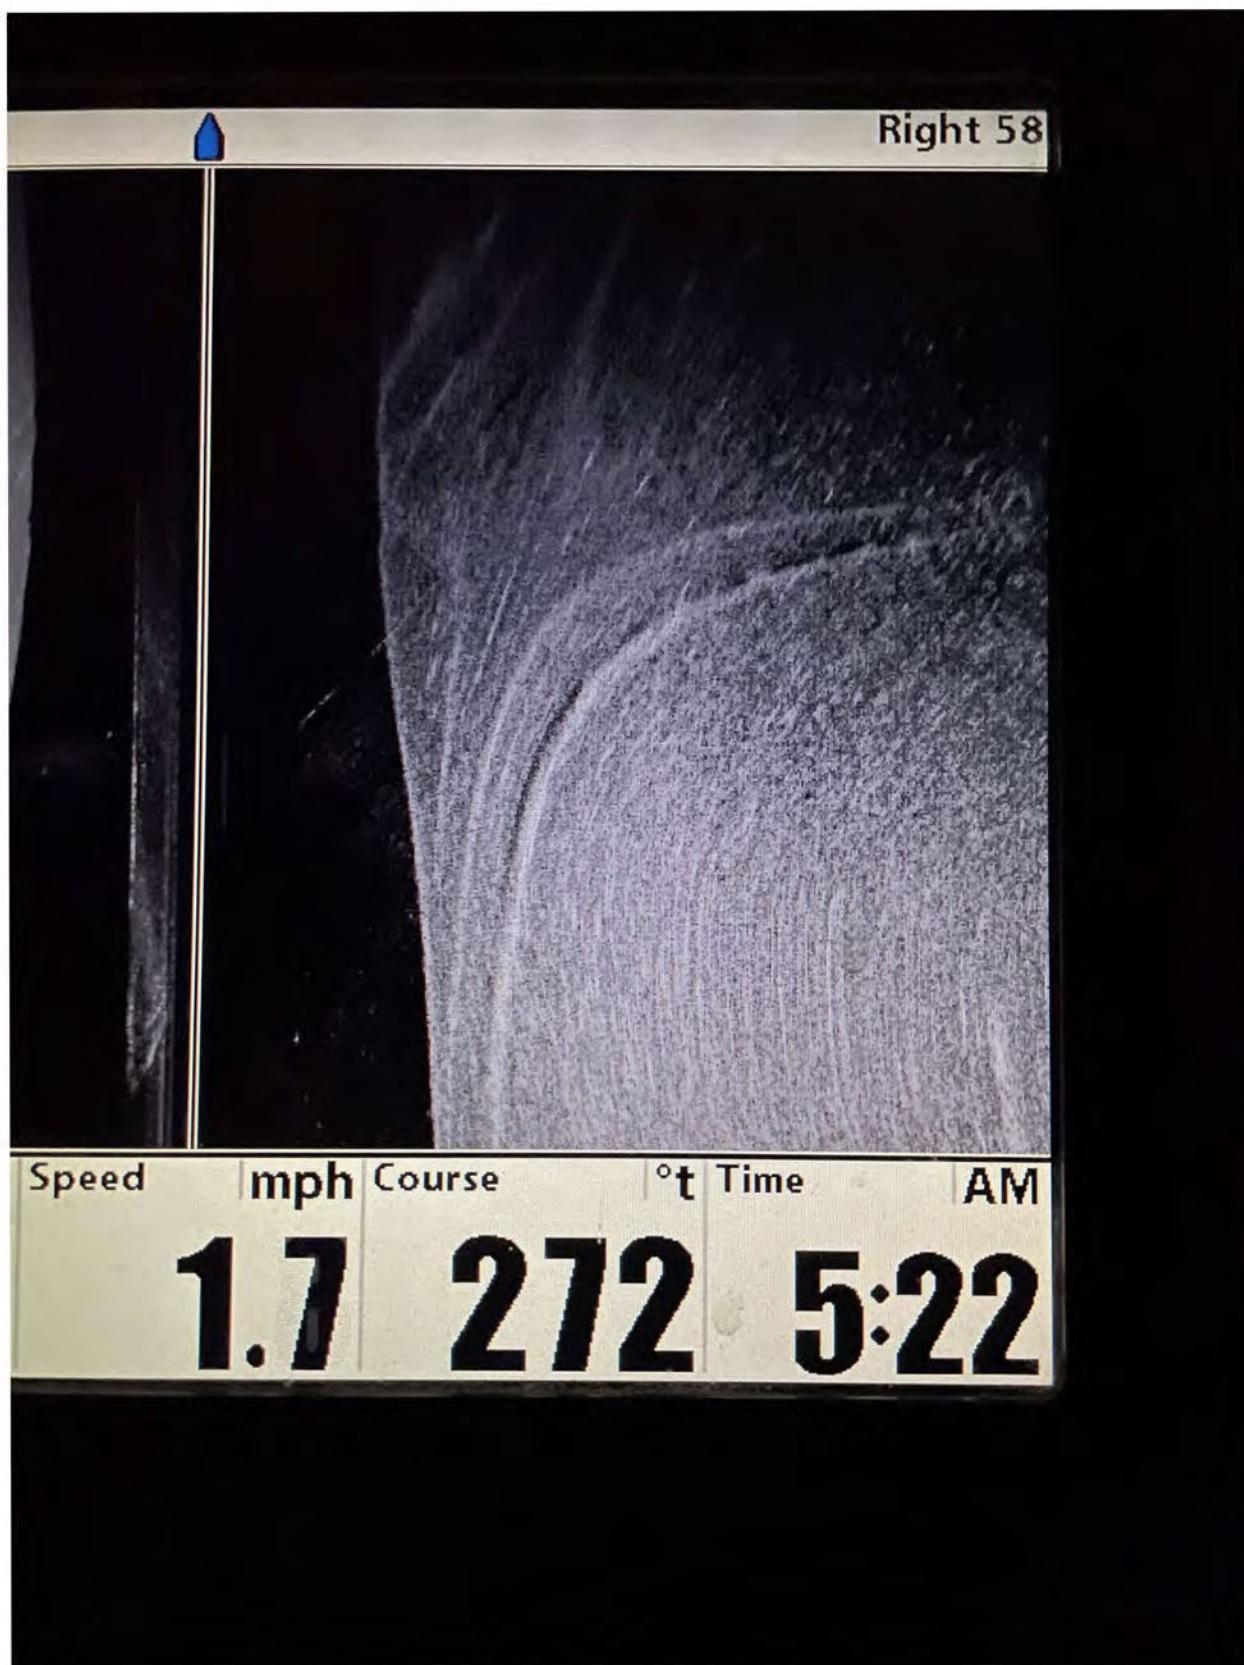
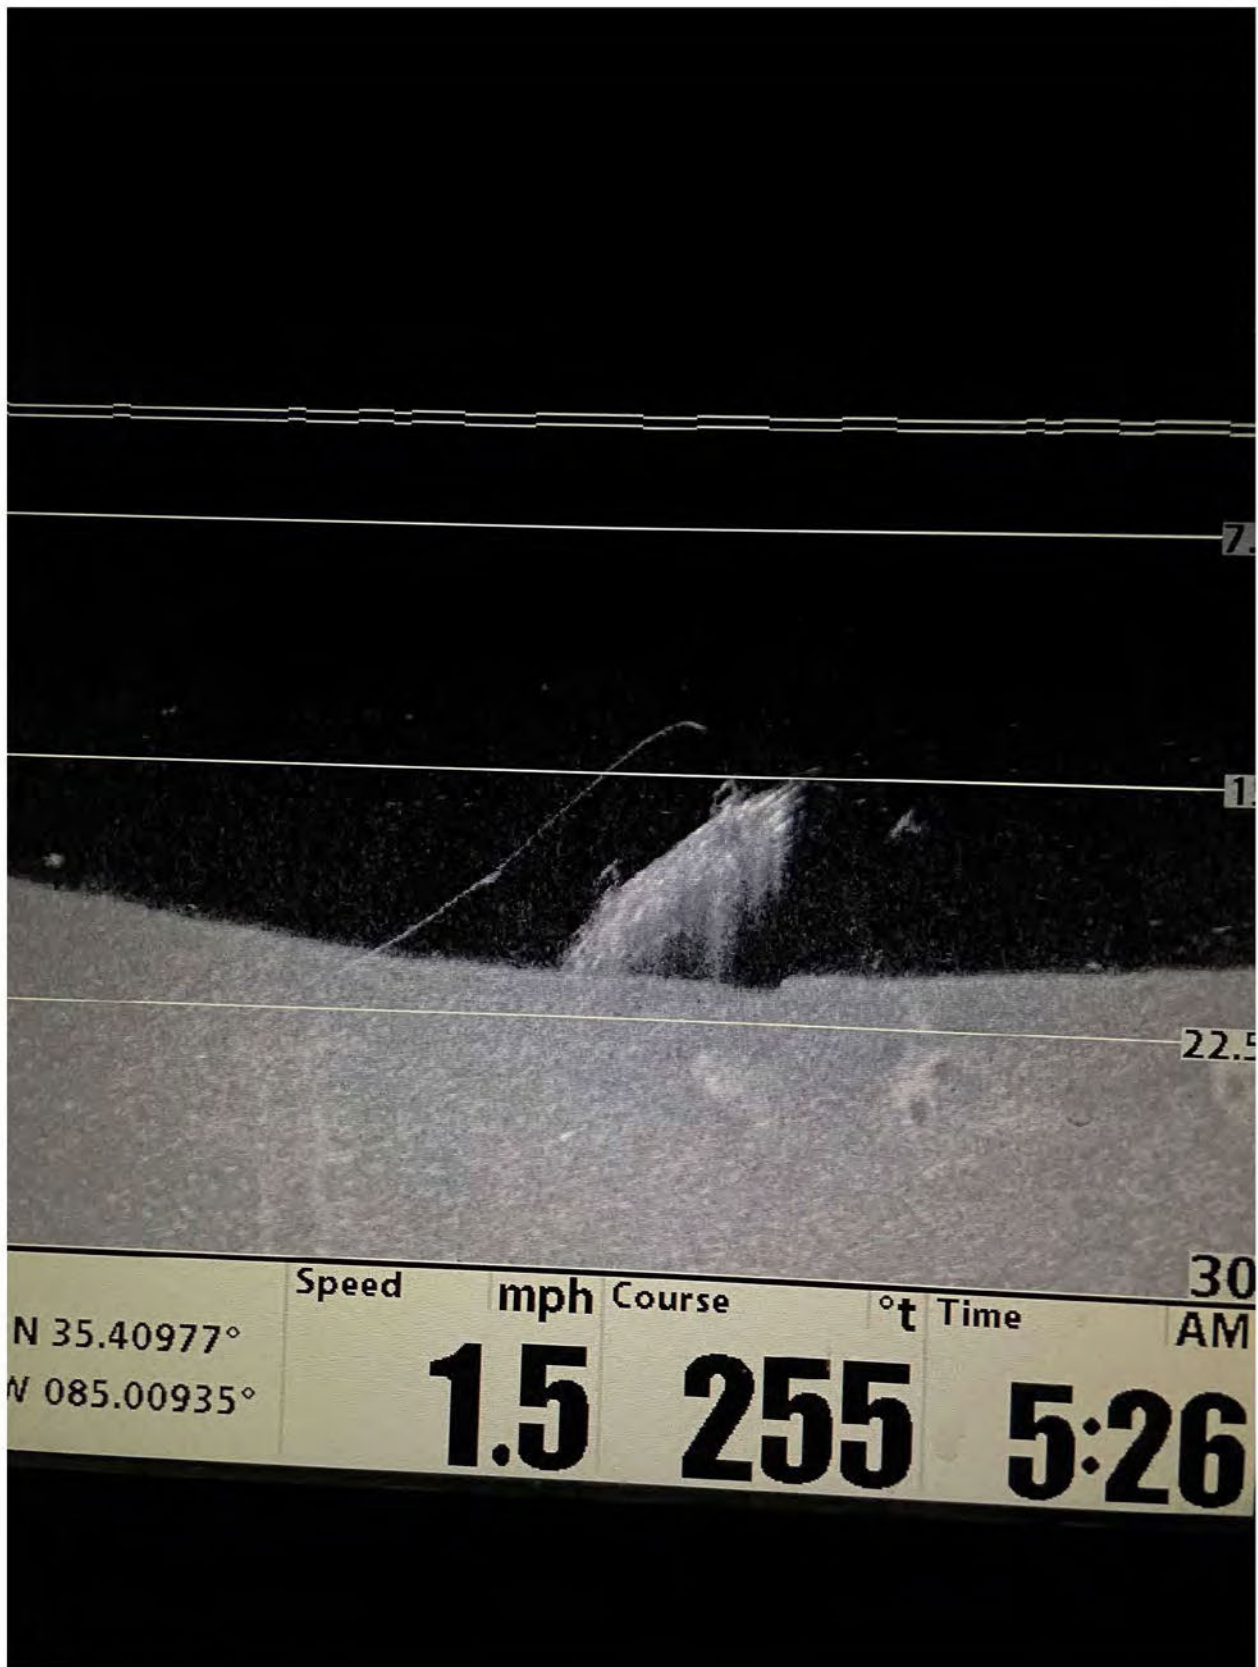
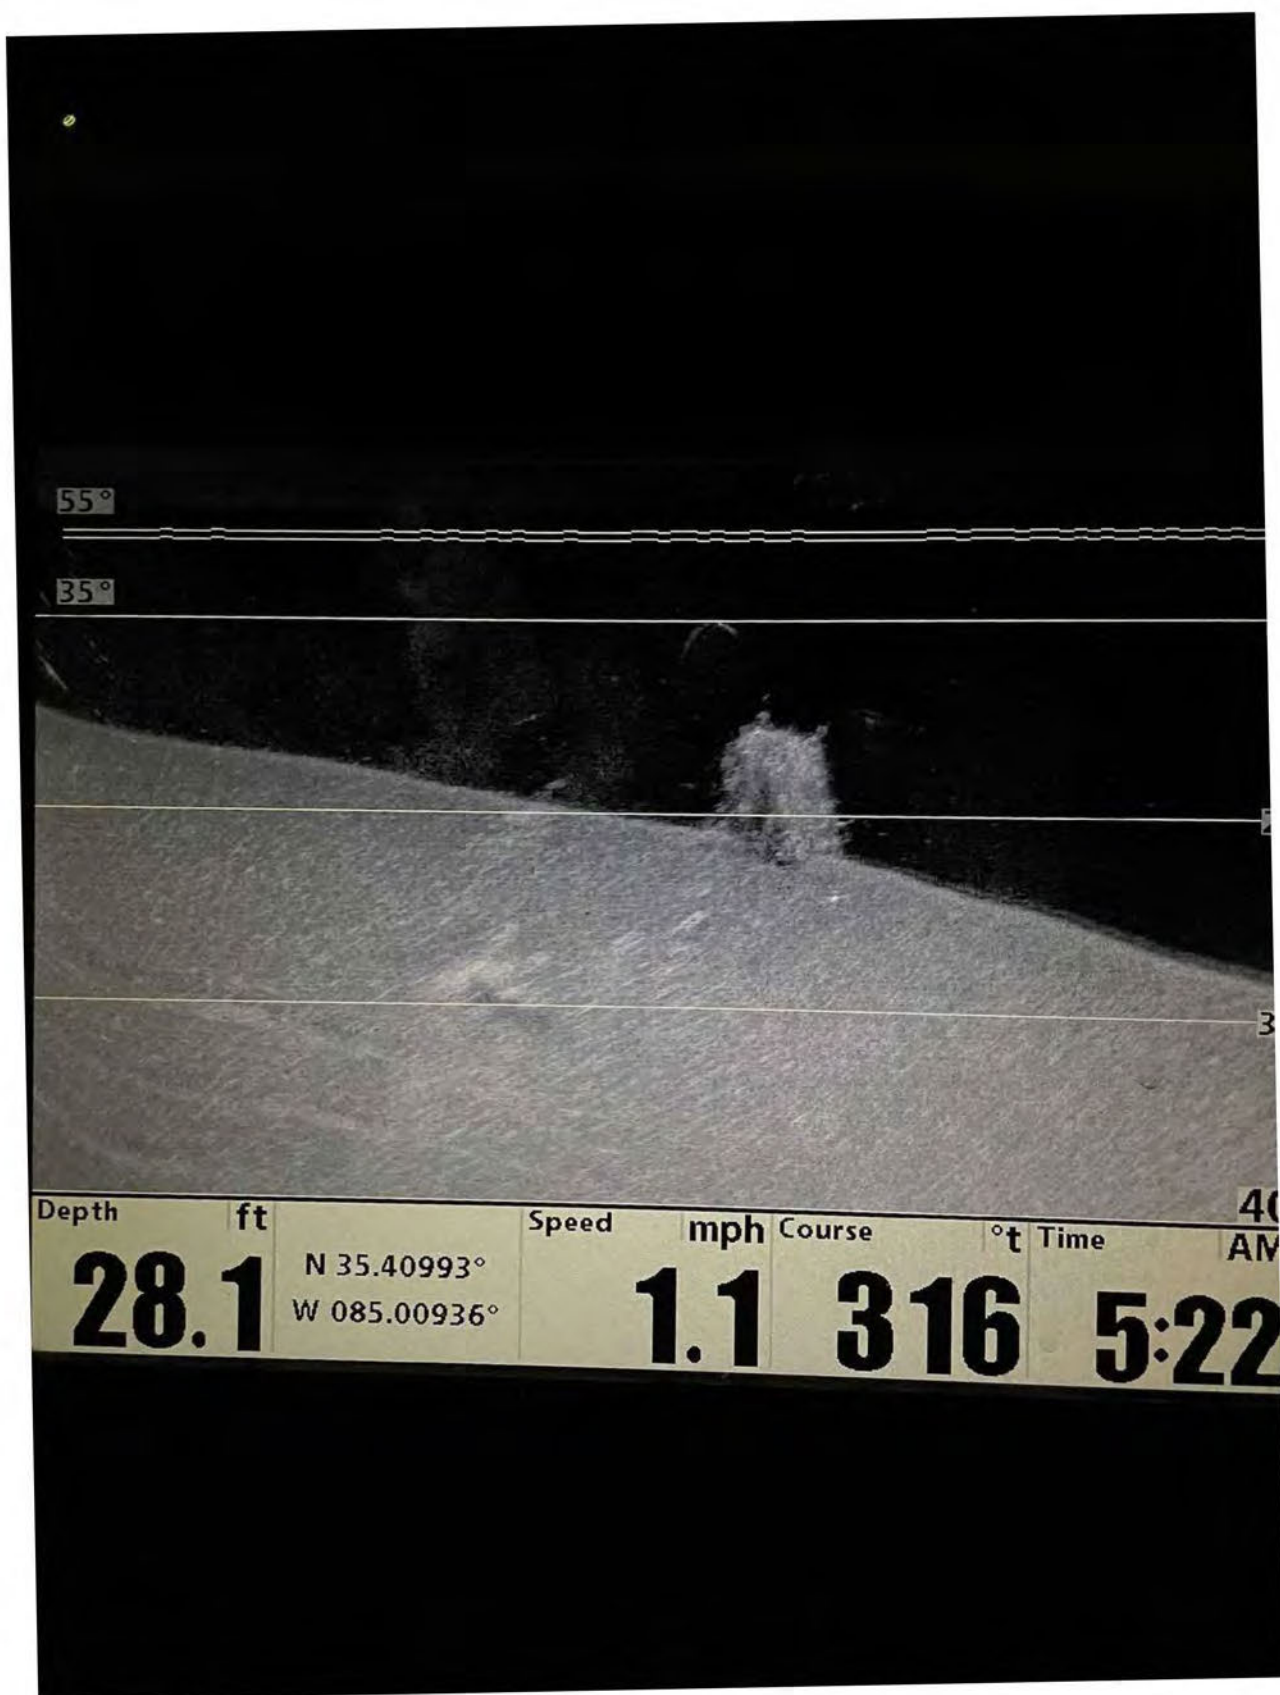
These are screen images taken by the ROV underwater vehicle during the recovery of Deputy Leonard's patrol vehicle from the river. These were provided by TWRA Officer David Holt.

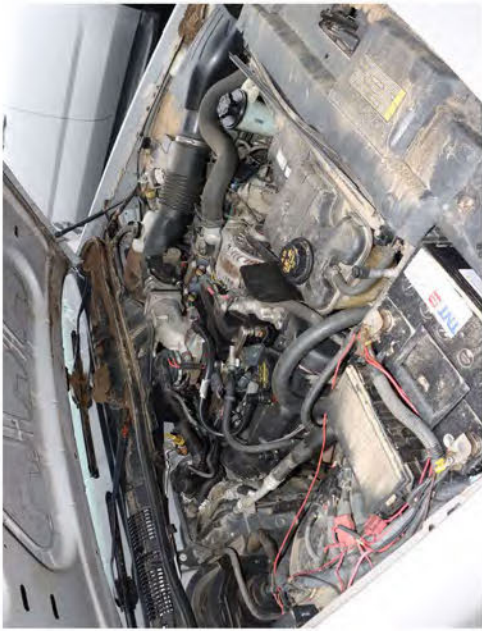
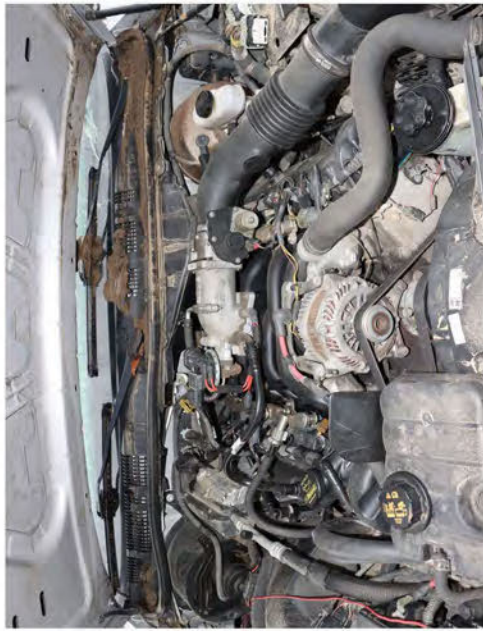
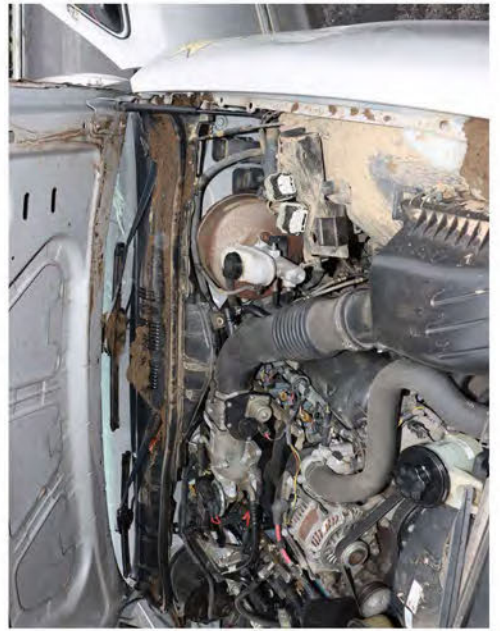
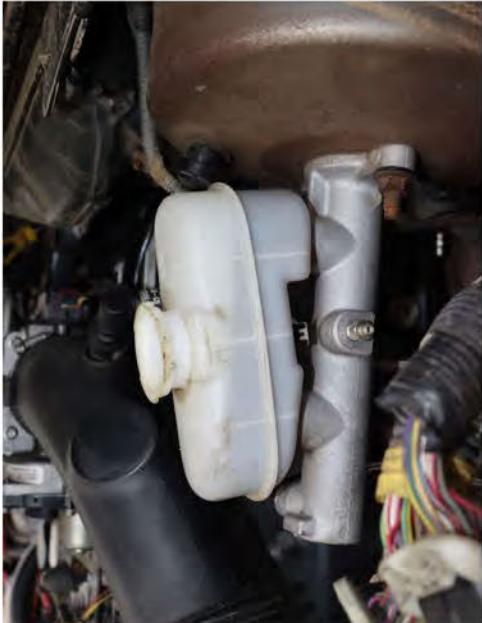
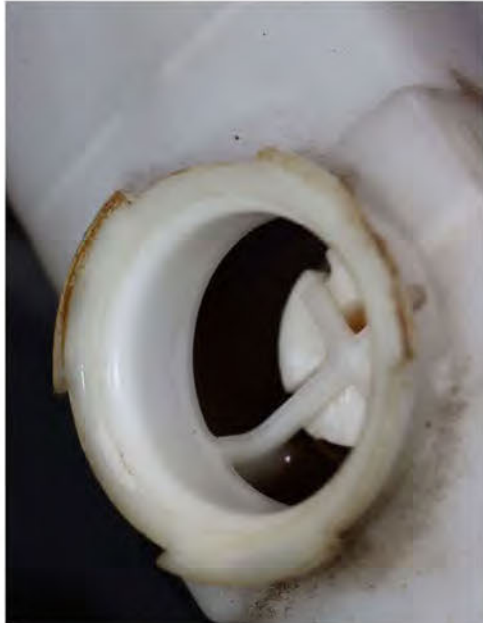
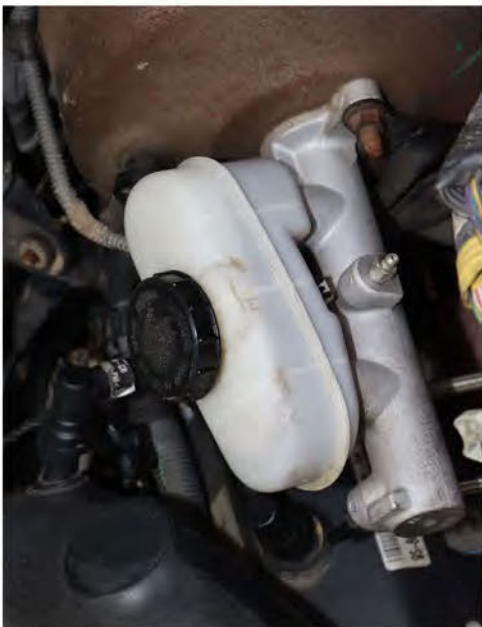
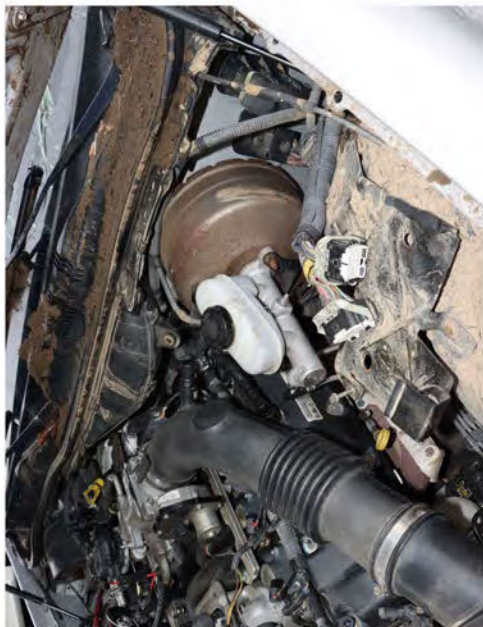
Crown Victoria Police Interceptor photos of the foundation braking components.

On April 18, 2024, I traveled to the THP Chattanooga District Headquarters, which was the location of Deputy Leonard's vehicle. I proceeded to conduct a visual inspection of the braking system components by removing each wheel and photographing the various parts of the foundation brakes. The brake fluid reservoir under the hood of the vehicle was also photographed. The throttle body, located on top of the engine, was photographed.

15. A general vehicle examination was conducted on Deputy Leonard's vehicle. During this exam, no obvious evidence was observed to suggest any type of mechanical complications were present that may have contributed to this incident. (Vehicle.)

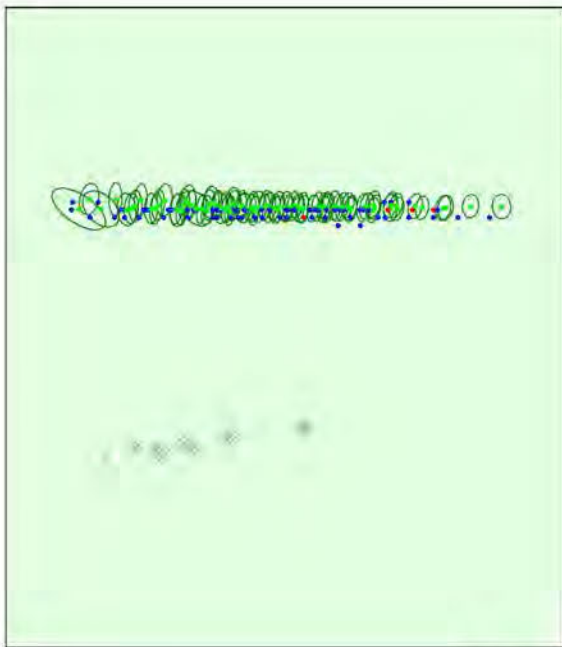
Uncertainty ellipses 100x magnified

Figure 3: Offset between initial (blue dots) and computed (green dots) image positions as well as the offset between the GCPs initial positions (blue crosses) and their computed positions (green crosses) in the top-view (XY plane), front-view (XZ plane), and side-view (YZ plane). Red dots indicate disabled or uncalibrated images. Dark green ellipses indicate the absolute position uncertainty of the bundle block adjustment result.
